Following last week's New Works meeting Philip Harrison carried out a site visit in relation to the wall behind Rufus Court. Please find his conclusions below with a really useful set of photos.

Following the New Works meeting last Thursday I went to look at the bit of brick wall that Rod Cox wants to demolish near Rufus Court. I am attaching some pictures of it that may help.

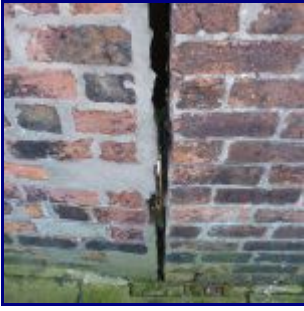
The brickwork is obviously quite old, (C18 ?) - but nothing special, and it was erected subsequent to the building of the houses/properties around Rufus Court, This is apparent from the vertical gap (see pic) which shows the bit of wall was never bonded into the wall of the adjacent house.

Rod Cox's Brick wall, near Rufus Court.
The crack between the brick wall and the gabled building.

- 1) that when demolition occurs the Archaeologist Dept. and structural engineers should be present to investigate the state of the Roman masonry.
- 2) The parapet section MUST be replaced by galvanized steel railings and oak post that match the existing railings running around the rest of the inside edge of the City Walls.

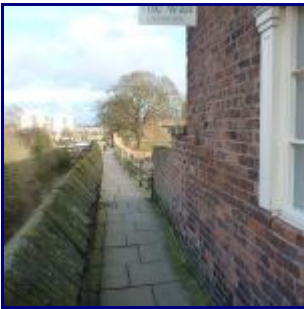
The bit of wall (approx.12ft. length) has been built up against the Roman City Wall and forms a parapet to the inside edge. It is now falling away into the green area behind 'Tea-on-the-Wall' café - (that very scruffy, collapsing bit of trellis roofing).

Rod Cox's Brick wall, near Rufus Court. On the Roman wall
looking North.

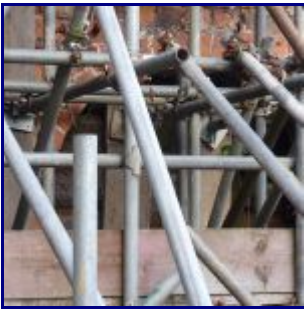
On the inside of the wall (Abbey Green side) a very substantial scaffolding has now been erected to prevent complete collapse (see pic). There are two arched openings in the brick wall through which it is just possible to see the masonry of the Roman Wall - which suggest that the brick wall was built for decorative purposes rather than as a support for defective Roman stone work.

Rod Cox's Brick wall, near Rufus Court. Picture taken from Abbey
Green.
The scaffolding supporting the collapsing brick wall.

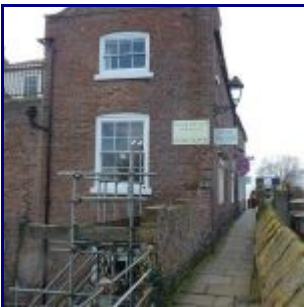
Rod Cox's Brick wall, near Rufus Court.
On the Roman wall looking South.
